Test Report

China Electric Power Research Institute
Quality Inspection and Test Center for Electric Equipment
of Power Industry
Test Report

Name: Capacitor voltage transformer

Type: TYD220/ $\sqrt{3}$ -0.01H

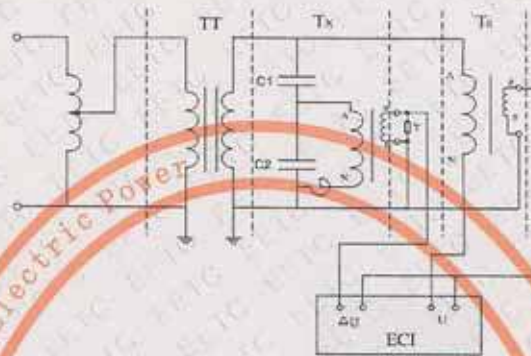
2.1.1 Test circuit diagram

TT: testing transformer Tx: tested object T₀: standard voltage transformer ECI: test set

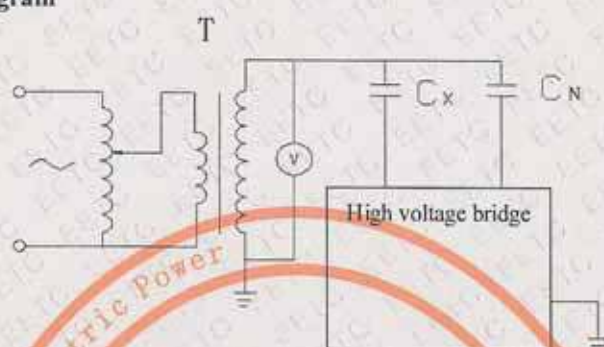
2.3.1 Test circuit diagram

T: testing transformer Cx: tested object C_N: standard capacitance

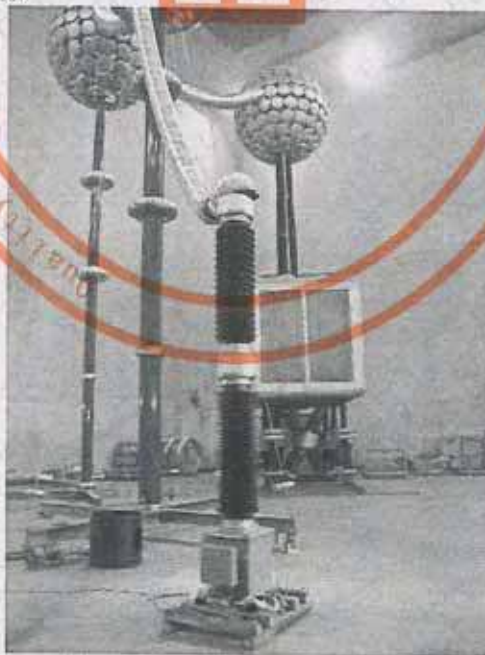
2.4.6 Photograph of test site

2.4 Electromagnetic compatibility test—Radio interference voltage measurement

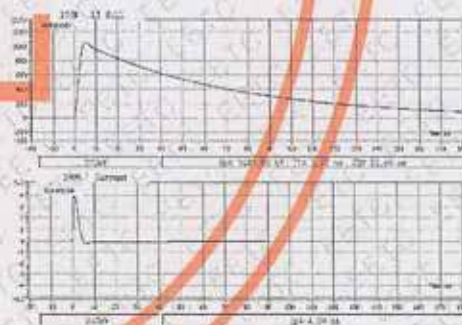
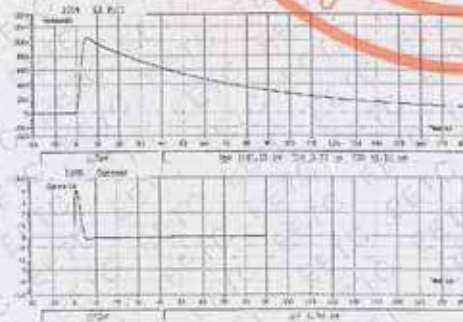
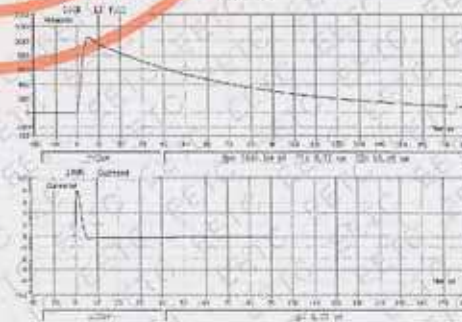
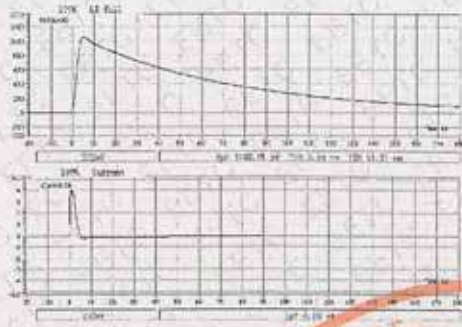
No.	Voltage polarity	Test voltage (peak)(kV)	Chopped time (after the peak) (μ s)	Waveform No.	Result
1	Pos.LI	571	/	1	Pass
2	Pos.LI	1048	/	2	Pass
3	Pos.LI	1047	/	3	Pass
4	Pos.LI	1048	/	4	Pass
5	Pos.LI	1048	/	5	Pass
6	Pos.LI	1048	/	6	Pass
7	Pos.LI	1048	/	7	Pass
8	Pos.LI	1048	/	8	Pass
9	Pos.LI	1047	/	9	Pass
10	Pos.LI	1057	/	10	Pass
11	Pos.LI	1056	/	11	Pass
12	Pos.LI	1057	/	12	Pass

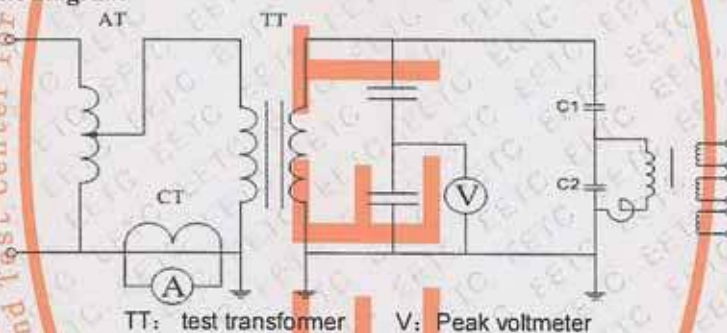
2.6.1 Test circuit diagram

In wet condition, the withstand voltage of 460kV shall be applied between the high voltage terminal and the earth for the duration of 1 min.

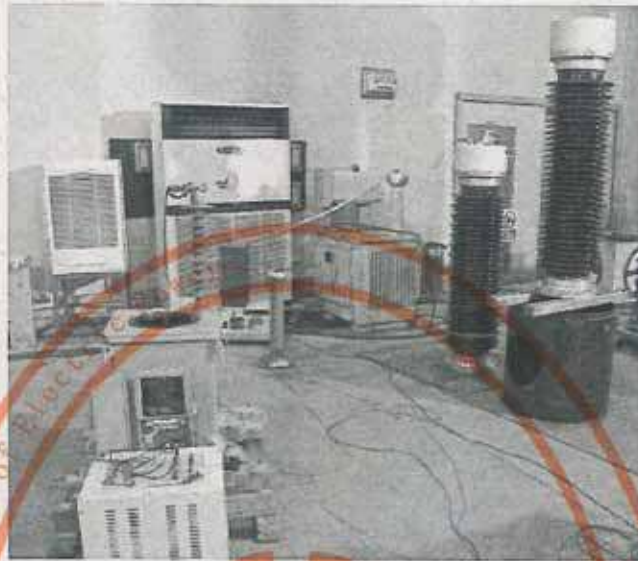
2.7.6 Photograph of test site

2.7 Transient response test

The tested object was both in good condition before and after this test. The capacitor voltage transformer could meet the requirements of the class 3PT1. This test has been passed.

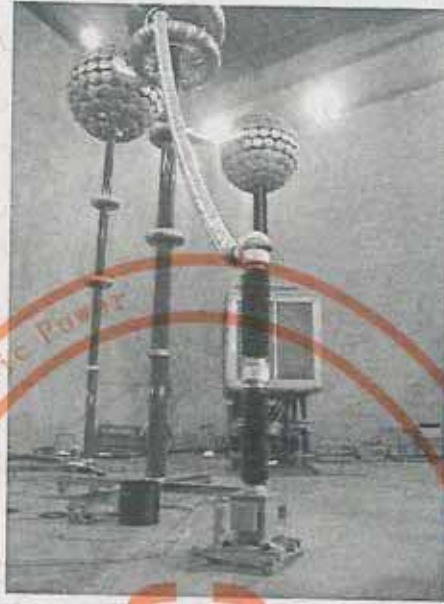
2.8.6 Photograph of test site

2.8 Ferro-resonance test

The tested object was both in good condition before and after this test. The test result could meet the requirements of reference standard. This test has been passed.

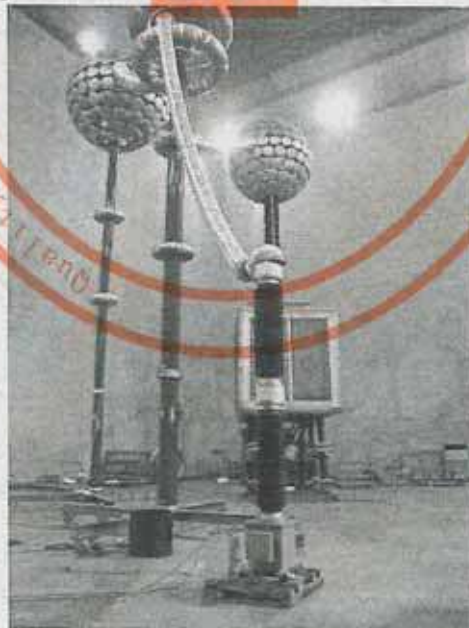
2.9.6 Photograph of test site

2.9 Short circuit withstand capability test

The r.m.s. value of the applied voltage at the transformer terminals shall be the rated primary voltage between phase and earth. The short-circuit applied between the secondary winding for the duration of 1 s. The capacitor voltage transformer shall be deemed to have passed this test if it satisfies the following requirements: ①it is not visibly damaged; ②its errors do not differ from those recorded before the tests by more than half the limits of error in its accuracy class; ③there is no significant change in the value of the capacitance; ④it can withstand the routine dielectric test; ⑤on examination, the insulation next to the surface of both primary and secondary windings of the e.m.u. does not show significant deterioration (this examination is not required if the current density in the winding does not exceed 160A/mm² where the winding is of copper).

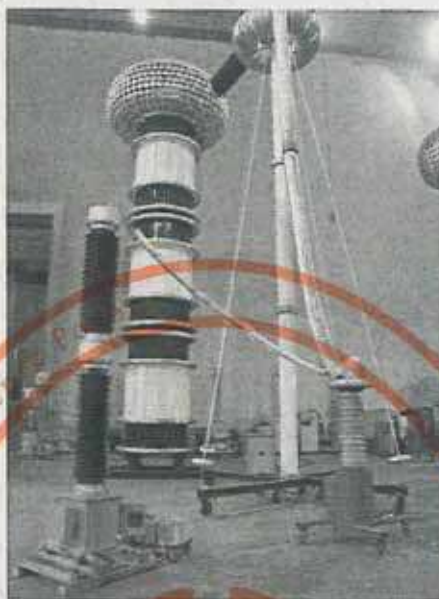
2.10.8 Photograph of test site

2.10 Accuracy test

The tested object was both in good condition before and after this test. The capacitor voltage transformer could meet the requirements of reference standard. This test has been passed.

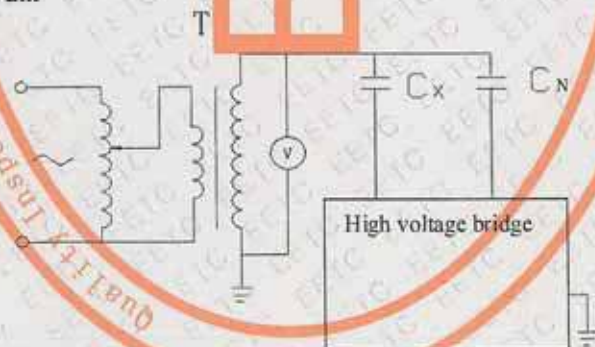
2.15.1 test circuit diagram

T: testing transformer Cx: tested object Cn: standard capacitor
